GEOMORPHOLOGICAL CHANGES CAUSED BY THE 2004 TSUNAMI IN THE COASTAL ENVIRONMENT OF WELIGAMA BAY AREA IN SRI LANKA

S. Wijeratne

Senior Lecturer, Department of Geography University of Ruhuna, Matara Sri Lanka

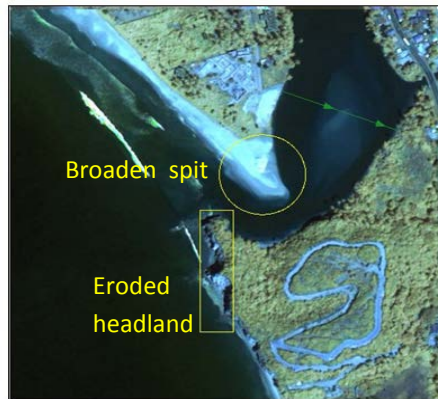
Fig. 04-Changes of Polwatta
Ganga estuary-after tsunami

Tsunami waves have flown 500 meters along the Polwatta Ganga and river meandering obstructed the further flow of water towards the upper areas. Because of this area of river banks sedimented with marine deposits and it damaged the mangroves about the 5 meters breadth along the both river banks.

Sand spit of estuary was developed by tsunami and sand accumulated on flood plain of the both sides of the river banks about in 2 feet thickness. Sand spit was spread in two meters and north of the estuary was broadened in two meters and deepened in one meter. By this time, landscape of the river outfall has become into the former condition, by the redevelopment of sand barrier. But, basement of the sea cliff has been eroded in 15 meters in height, because the tsunami wave attacked on the cliff base. However, the damage of the estuary was less than Weligama bay area as a result of refracted tsunami waves from the Pemuyana headland.

North of the Polwatta Ganga estuary was spreader in about 5 meters and the breath of sand spit of the estuary was increased in about two meters. The Tsunami waves attacked to the Pemuyana headland in the south of the bay occurring serious damaged to the Weligama town area and base of the headlands was eroded about one Meter and they were narrowed because of the erosion of 300 meters of the headlands. Rassamuna headland in the north of Weligama bay was eroded more than Pemuyana headland.

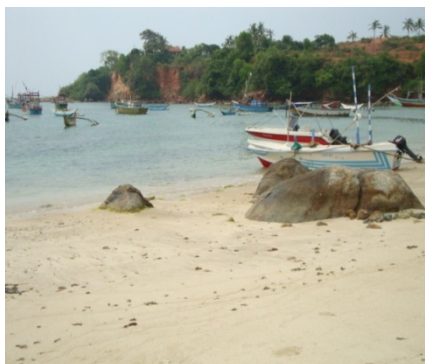
Fig. 04-Progradated beach after tsunami
by accumulation of Sand-Kapparatota

The bay was geomorphologically changed because of sand deposition on the north part of it. Tsunami wave refracted towards the north-west of the bay, and the northern part of the bay beach was formed further with beach materials transported by the tsunami waves from south to north direction. It has caused to develop a broaden beach at about 15 meters in width and former offshore coast had changed into a sandy beach now. As a result of this, it is clear that the Kapparatota natural harbor has changed into a bay beach area. (See fig 04 and 05)

The bay was geomorphologically changed because of sand deposition on the north part of it. As a results of this the Kapparatota natural harbor which was Located in the northern part of the bay has become into a bay beach by sand deposition.
